# Manhole Inspection Summary

Manhole # S04EE2007MH

**Location** Address: **3501 CROSS COUNTRY BLVD** Cross Street: **FALLSTAFF RD**

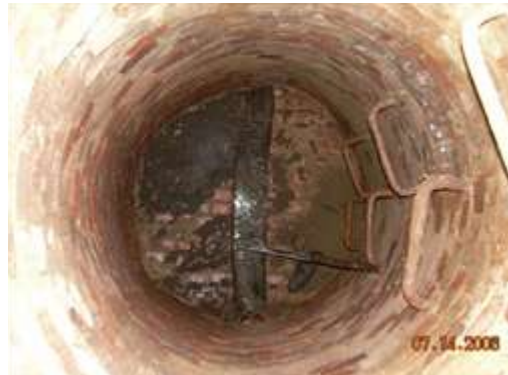
Top View

Adjustment and Corbel infiltration.  
Corroded steps. Evidence of surcharge -  
Bench debris.

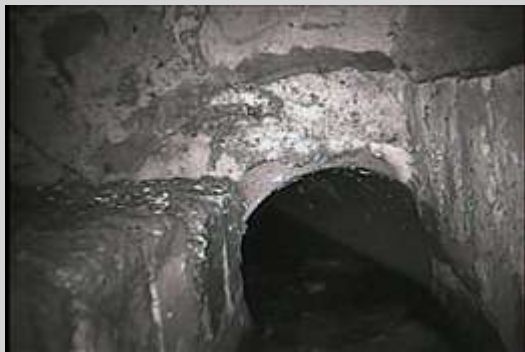
### 8 in. Circular Gravity Sewer Pipe Out @ 12 O'Clock

Invert Depth: **11.55** (ft.) Flow Characteristics: **Slow**

Deposits: ☐ None ☐ Mud ☐ Sludge ☒ **Debris** ☐ Grease

Silt Depth: **0.25** (in.) Deposits Extent: **Light**

Infiltration: **None** Pipe Seal Cond: **Unknown**

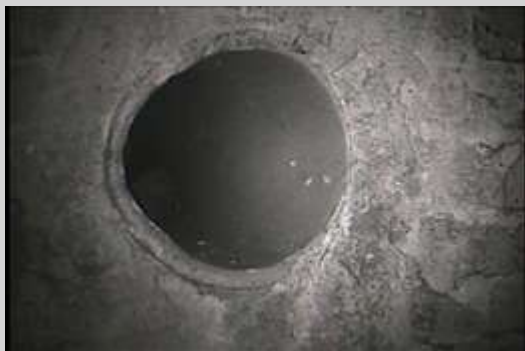
### 8 in. Circular Gravity Sewer Pipe In @ 6 O'Clock

Invert Depth: **9.90** (ft.) Flow Characteristics: **Slow**

Deposits: ☒ **None** ☐ Mud ☐ Sludge ☐ Debris ☐ Grease

Infiltration: **None** Pipe Seal Cond: **Unknown**

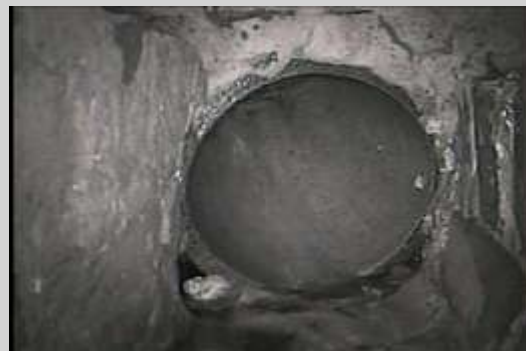
### Drop In @ 6 O'Clock

Drop: **Outside** Rod and Bar

Angled: **Yes** Reading: **10.25** (ft.)

Inv Depth: **11.25** (ft.)

Drop Condition: **Open**

Connects To: **Dead End**
